# SPARC® Enterprise M8000/M9000 Servers Product Notes

For XCP version 1060

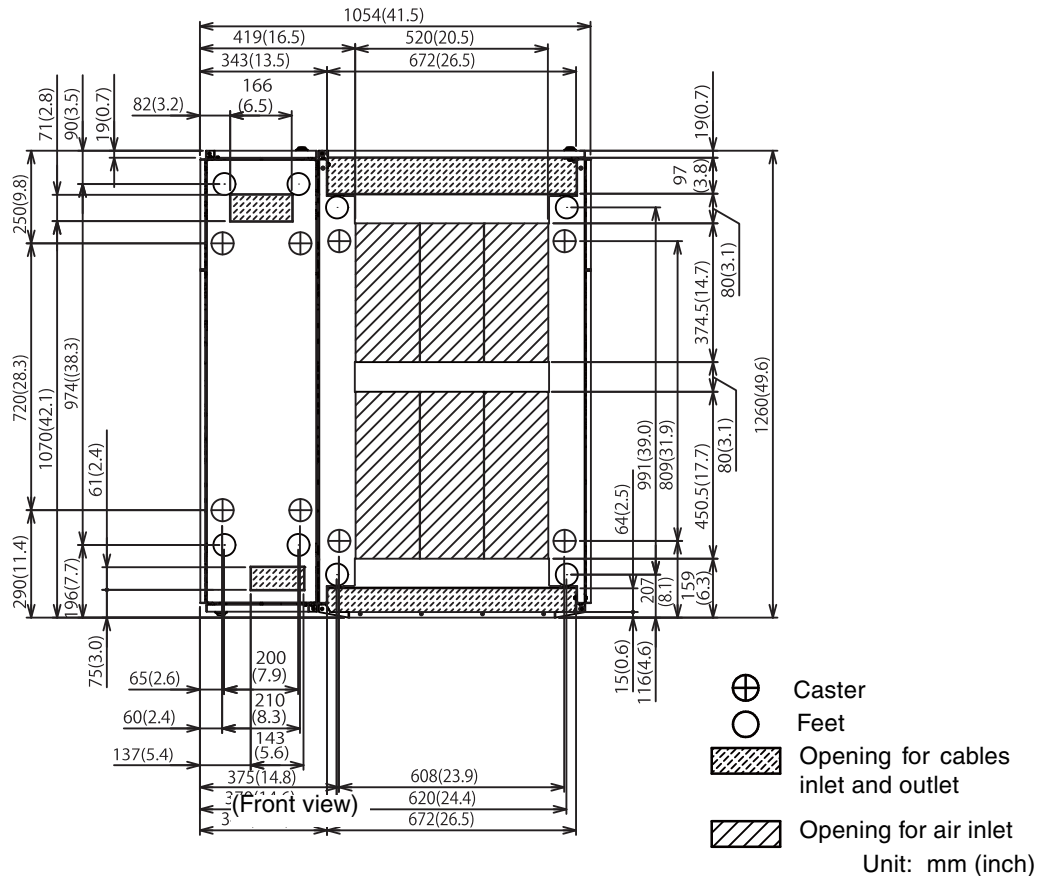
**FIGURE1-18** SPARC Enterprise M8000 Server + Power Cabinet Bottom View

This is to correct the description in Section 1.2.2.2, "Bottom View of the Components", FIGURE 1-18 SPARC Enterprise M8000 Server + Power Cabinet Bottom View and FIGURE 1-20 SPARC Enterprise M9000 Server (Base Cabinet) + Power Cabinet Bottom View. The correct figures are as follows:
